Low-Cost Shore Protection

Final Report on the Shoreline Erosion Control
Demonstration Program (Section 54)
1981

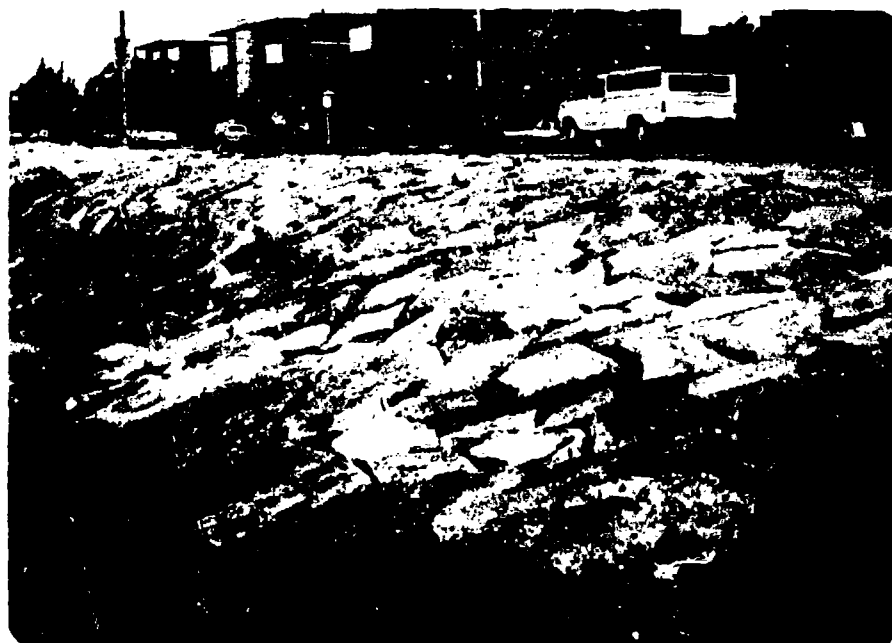
2 Performance. The 75-foot revetment, completed after the March 1979 storm, was undamaged with no significant loss of retained sand (Figs. 2-275 and 2-276). The buildup of sand in front of the revetment due to the groin action of device 8 prevented direct impact of waves on the structure, and wave uprush deposited a considerable amount of sand on its face, nearly blanketing the rubble. This additional sand buildup prevented device 7 from being damaged by the February 1980 storm waves (as at device 6 with no sand buildup) (Fig. 2-277). The profiles through device 7, compared with those through similar devices, are shown in Section III, Figure 3-43. The profiles of March 1979 and September 1979 show the accretion of sand in front of the structure. Some erosion was present at the junction of devices 7 and 8.

Figure 2-275. Sized rubble revetment with filter cloth, device 7, Alameda, California, 21 June 1979.

Figure 2-276. Sized rubble revetment with filter cloth, device 7, Alameda, California, 21 August 1979.

Figure 2-277. Device 7 as of 20 February 1980, Alameda, California.

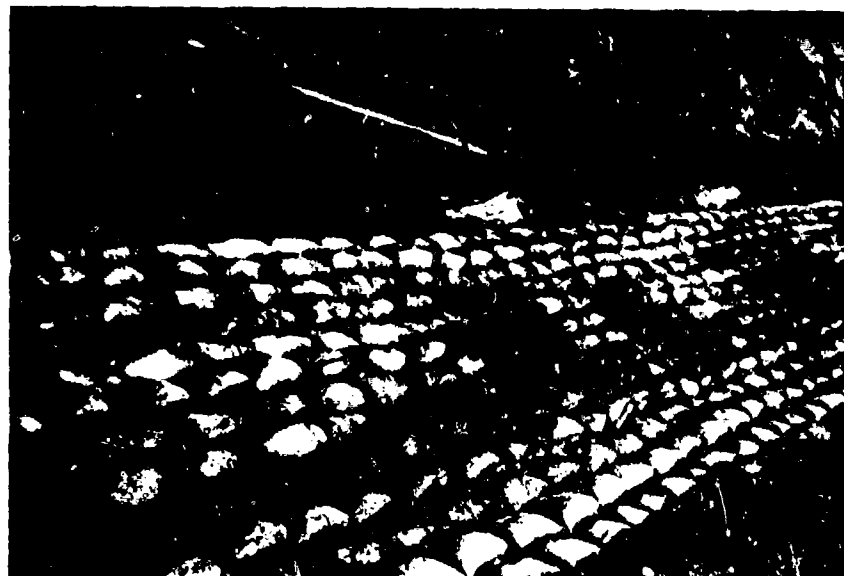
Devices 1a and 1b (sand-cement bags) were undamaged with the exception that most of the toe protection material had been displaced (Fig. 2-340). Drift debris littered the backfill area along most of this reach (Fig. 2-341).

Figure 2-340. Device 1a intact following the February storm, Oak Harbor, 14 February 1979.

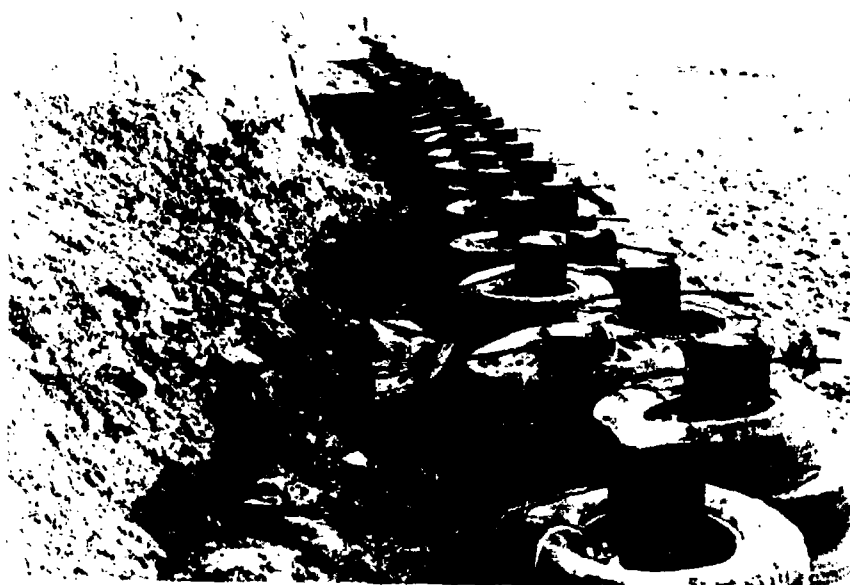
The western part of device 3bW (used-tire bulkhead without filter material) suffered significant erosion of the silty sand backfill material (Fig. 2-345), but the structure did not appear to be in immediate danger of failing. In device 3aE (used-tire bulkhead without filter) the pit-run gravel used for backfill was apparently coarse enough to prevent rapid erosion of the material from behind the tires (Fig. 2-346). Devices 3aW and 3bE (used-tire bulkheads with cloth and gravel filters, respectively) were not damaged except for a 1-foot-deep by 2-foot-wide scour area (topsoil) behind 3bE (Fig. 2-347). Most of the gravel was washed from the tires all along device 3, and a tire settlement of 6 to 10 inches occurred (probably because the tires flattened as the gravel washed out).

Figure 2-345. Erosion of the sand backfill from behind device 3bW, Oak Harbor, 14 February 1979.

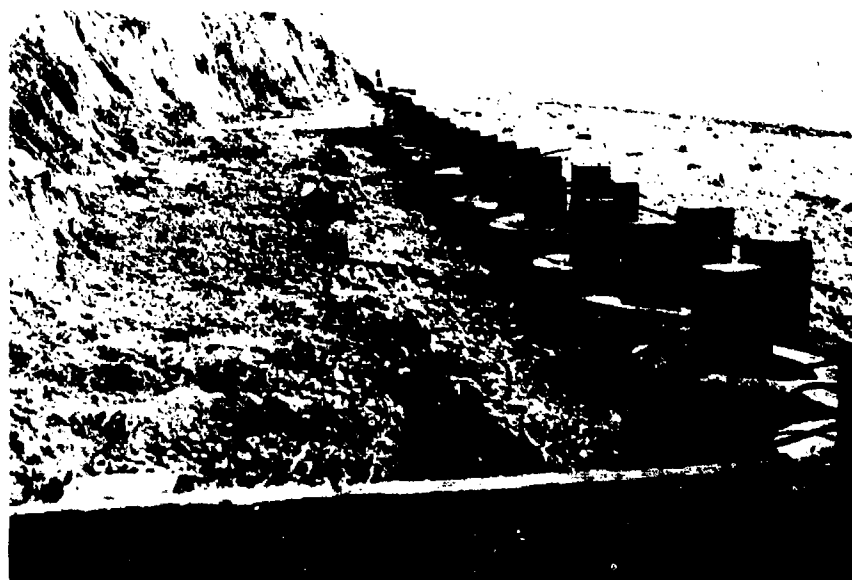
Figure 2-347. Scour trench behind device 3bE (with a gravel filter), Oak Harbor, 14 February 1979.

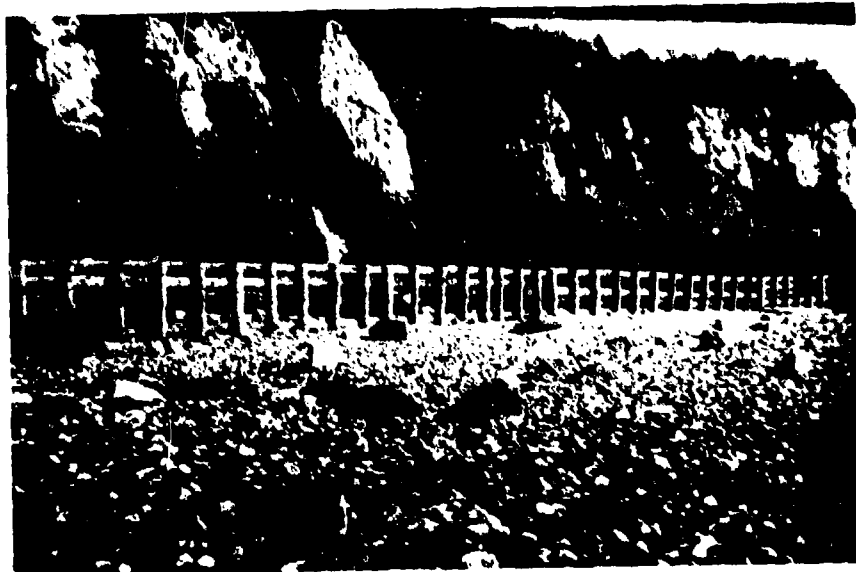
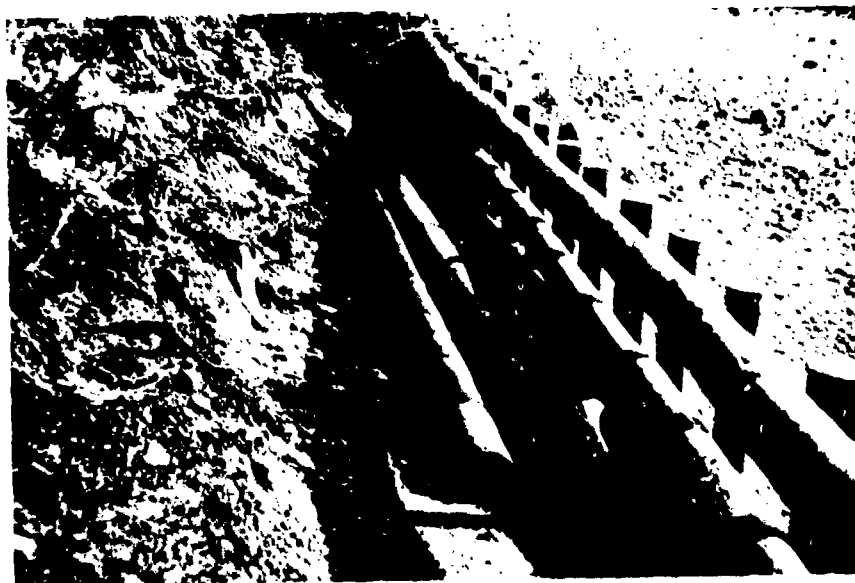
Device 4 (timber bulkhead) was damaged extensively; device 4a (horizontal logs) was essentially destroyed. All backfill material was washed out, and a number of the horizontal logs were removed (Figs. 2-348 and 2-349). The western part of device 4a had no filter, and the fine (silty sand) backfill material was easily washed through the logs. Apparently the gravel filter material in the eastern part of device 4a was undersized and was washed through voids between the logs. Once a breach in the filter had been established, the backfill material (pit-run gravel) escaped. A small void under the separation bulkhead between 4aW and 4bE allowed about 20 cubic yards of material to escape from behind 4bE (treated plank bulkhead with cloth filter) (Fig. 2-350). In device 4bW (treated planks without filter material), all of the silty sand backfill (about 110 cubic yards) was eroded (Fig. 2-351). Much of the toe protection was displaced along device 4b, exposing a gap of 1 to 2 inches below the bottom plank, which allowed the backfill to escape. The destruction of devices 4aW and 4bW exposed the separation bulkheads on each end of 4bE.

Figure 2-348. Extensive damage to device 4a, Oak Harbor, 14 February 1978.

Figure 2-349. Backfill completely washed out from behind device 4a, Oak Harbor, 14 February 1978.

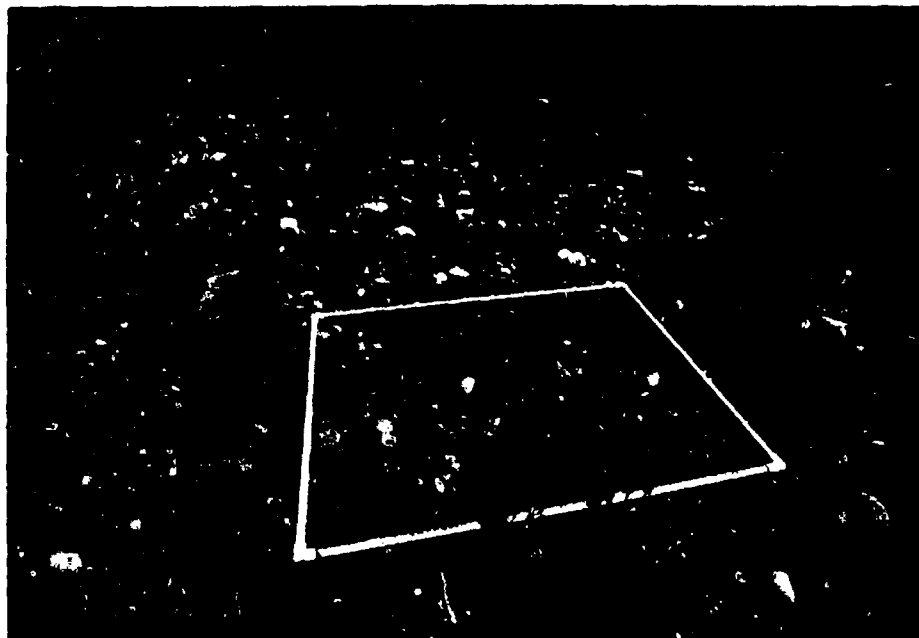
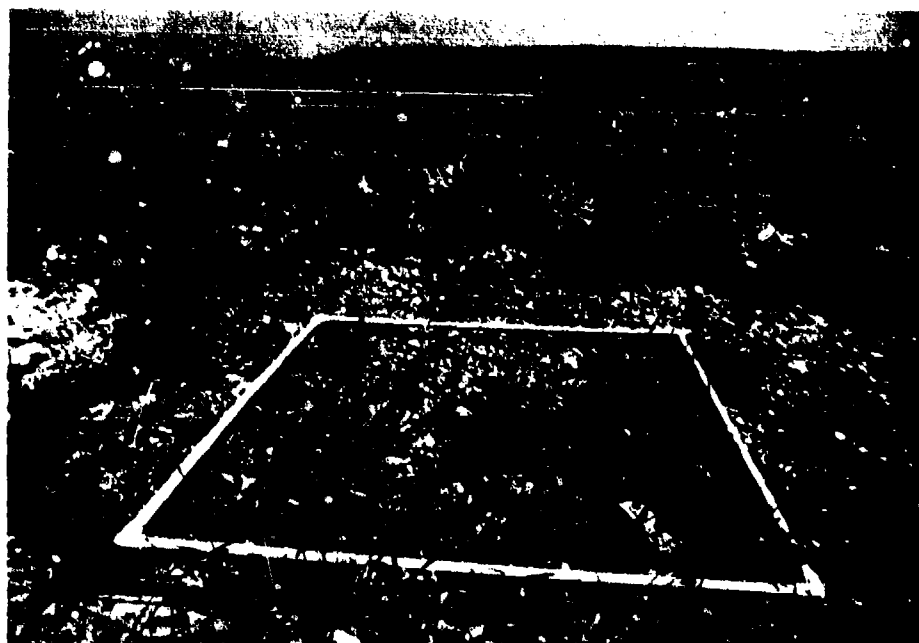
(d) Vegetation Plantings. Success of plantings at this site was low due to extreme weather and the damage to the structures below the plantings (Figs. 2-352 and 2-353). The severe storm in February 1979 removed the backfilled material in areas behind devices 3b, 4a, and 4b, and these could not be sampled. The area behind device 2a was also not sampled as repair to the structure deposited a layer of gravel cobble over the plantings. It was seeded with large variety tall wheatgrass in September 1979, but sampling was not performed until 1980.

Figure 2-352. Destroyed vegetation area behind the gabion
revetment, Oak Harbor.

Figure 2-353. Vegetation plantings behind the used-tire
bulkhead, Oak Harbor.

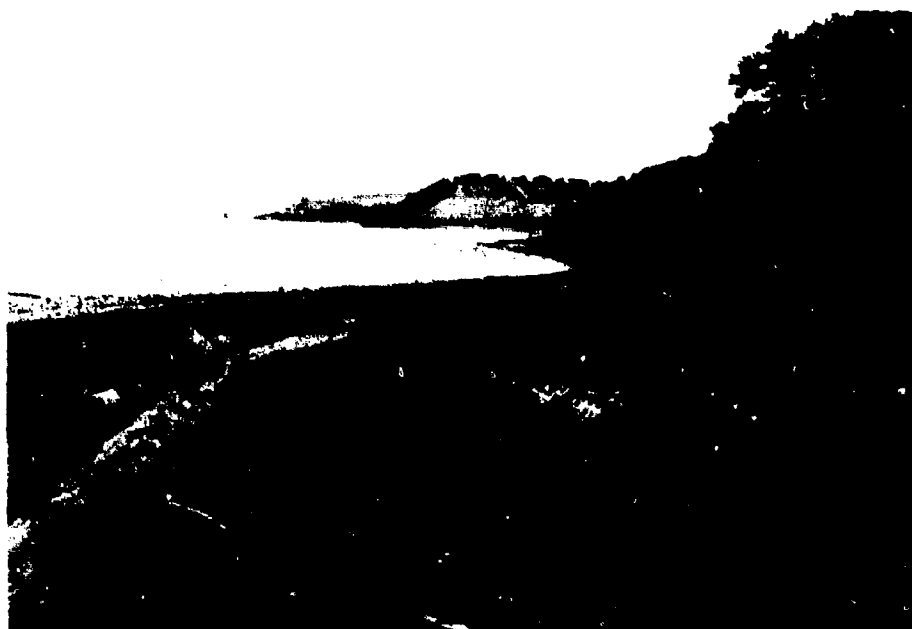
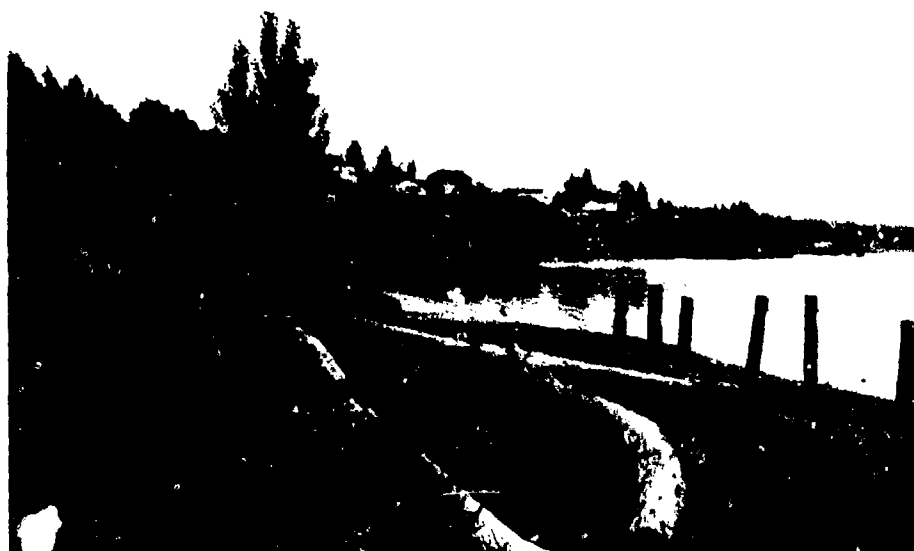
(3) Performance. After 1 year of monitoring, the heavily used recreation beach continues to protect the park and sewage facilities. The beach has also prevented further deterioration of the timber bulkhead protecting the park area (Figs. 2-364 and 2-365). Volume calculations of erosion and accretion show that both trends are present at the site (Table 2-94). Erosion has occurred primarily from station 0+00 to 2+00 and from station 6+00 to 12+50. Major accretion areas range from station 2+00 to 6+00 and from station 12+50 to 19+00. The net accretion of nearly 4,000 cubic yards between the 1979 and 1980 surveys is an anomaly, in view of the long-term record of continuous erosion at this site. A longer monitoring period is needed to develop a better account of littoral movement in this area. Profiles of the eroding sections show a minor

Figure 2-364. Sunnyside Beach from the park center looking north, 29 May 1980.

Figure 2-365. Sunnyside Beach from the park center looking south, 29 May 1980.

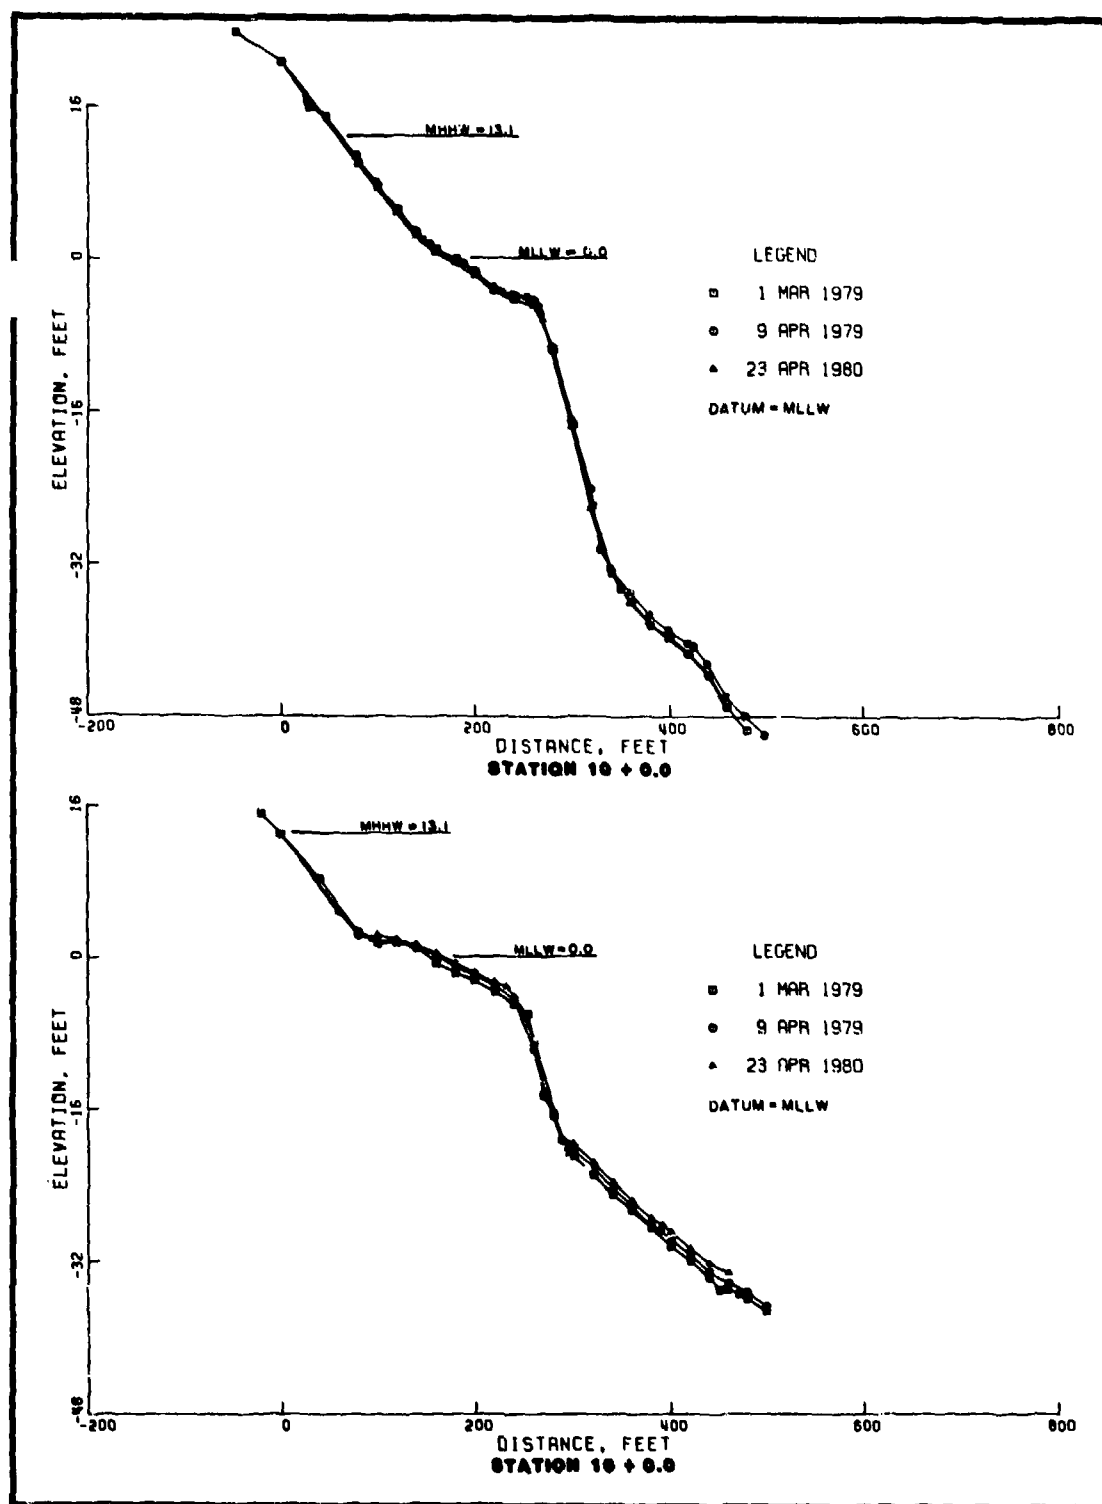
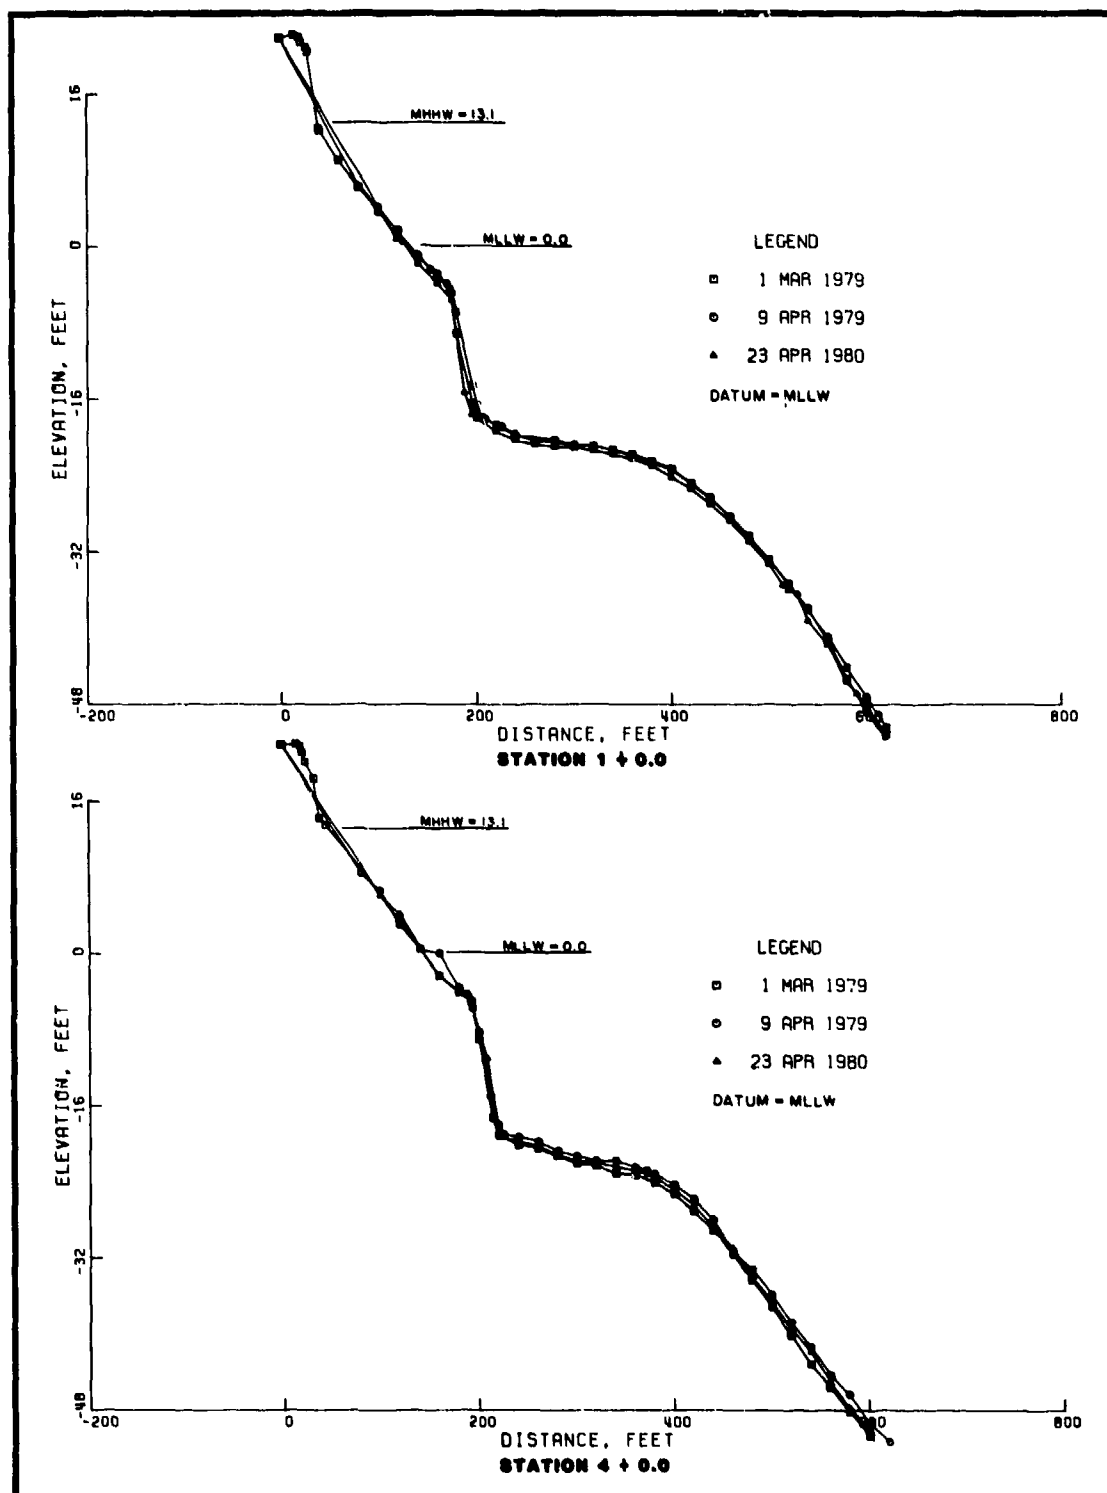
amount of accretion between March and April 1979, but then an overall erosion up to April 1980. The profiles at station 16+00 show continual accretion (Fig. 2-366), and station 4+00 shows a fluctuation between accretion and erosion (Fig. 2-367).

Figure 2-366. Typical profiles, Sunnyside Beach.

Figure 2-367. Typical profiles, Sunnyside Beach.

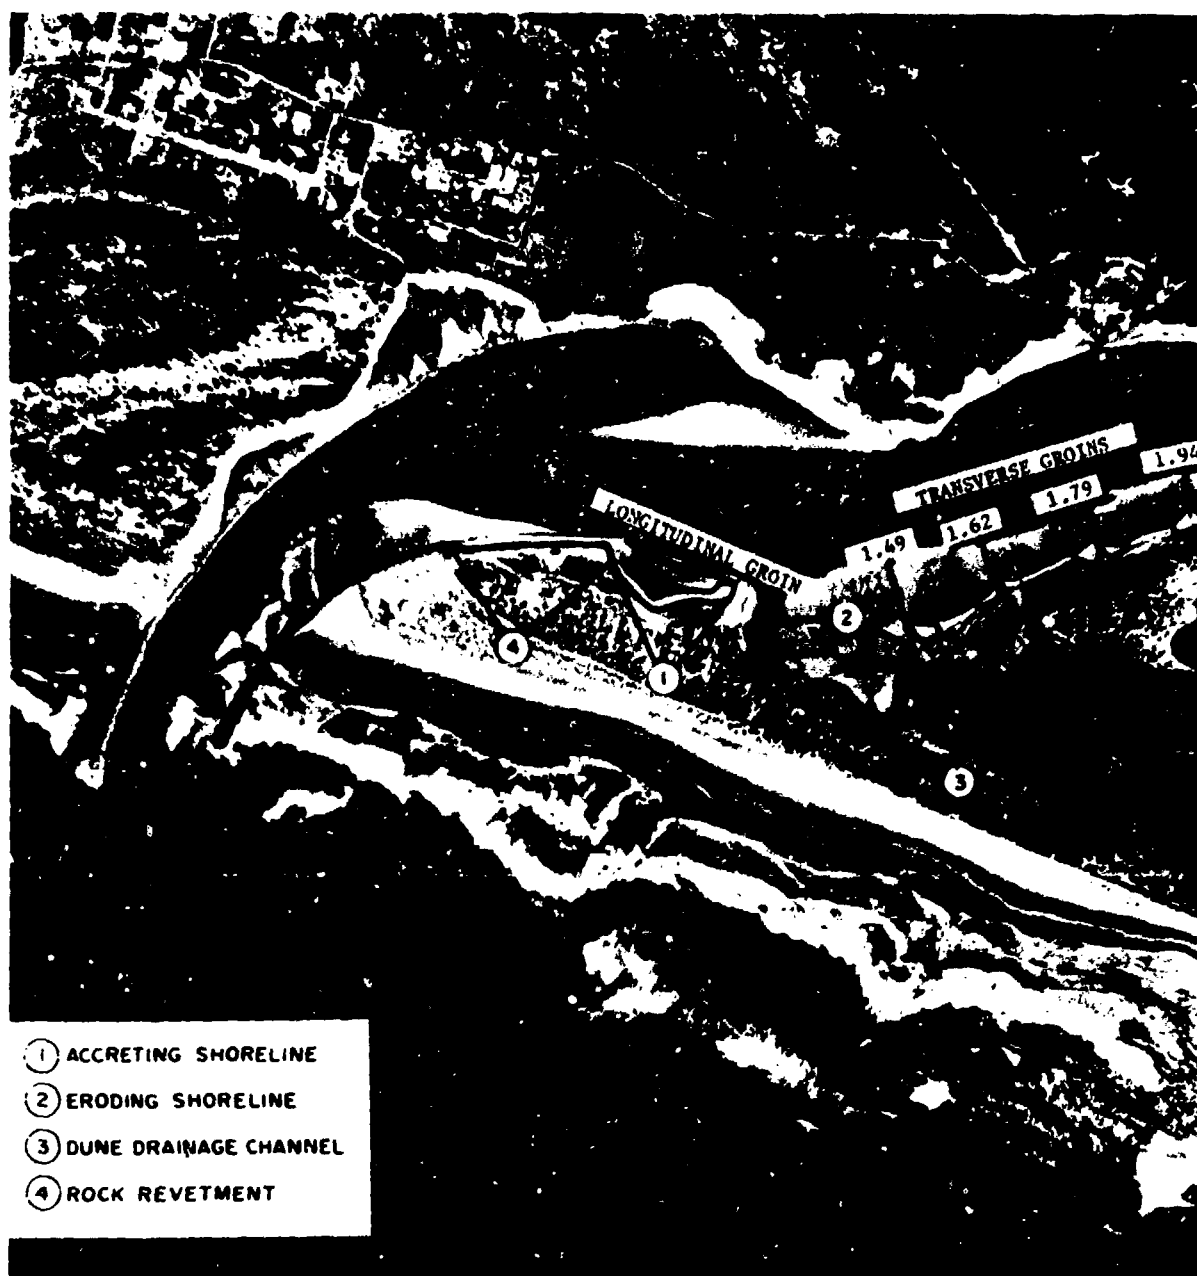
channel ceased its westward migration when the five groins were installed. Bank erosion had threatened to breach the spit and form a new outlet to the ocean somewhere along the shoreline where the revetment and longitudinal groin are now located. However, this area is now accreting. During the monitoring period, a large amount of sand accreted on both sides of the base of each transverse groin except at groin 1.49 where erosion occurred on the north side because the dune drainage channel had swung westward against the bank. Figures 2-377 to 2-383 show these trends as of December 1978.

Figure 2-377. Accretion and erosion trends along the shoreline of Siuslaw River, Oregon, 17 March 1979.

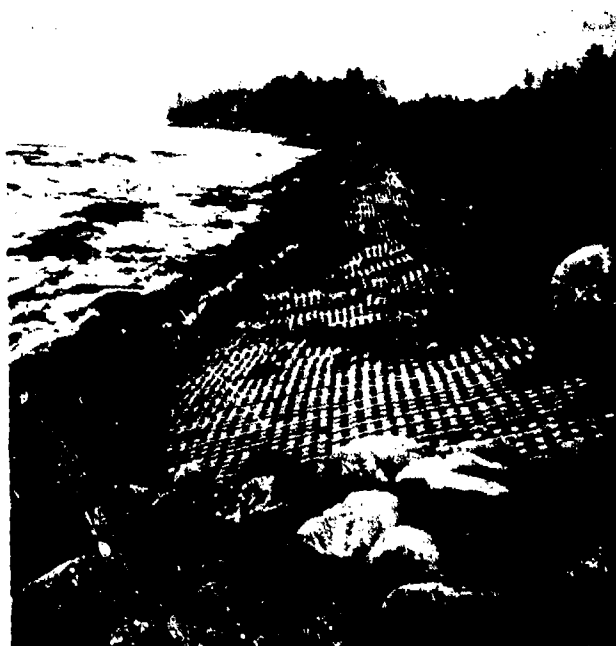
Figure 2-403. Intact western segment of the Turfblock revetment, Port Wing, Wisconsin, 7 May 1979.

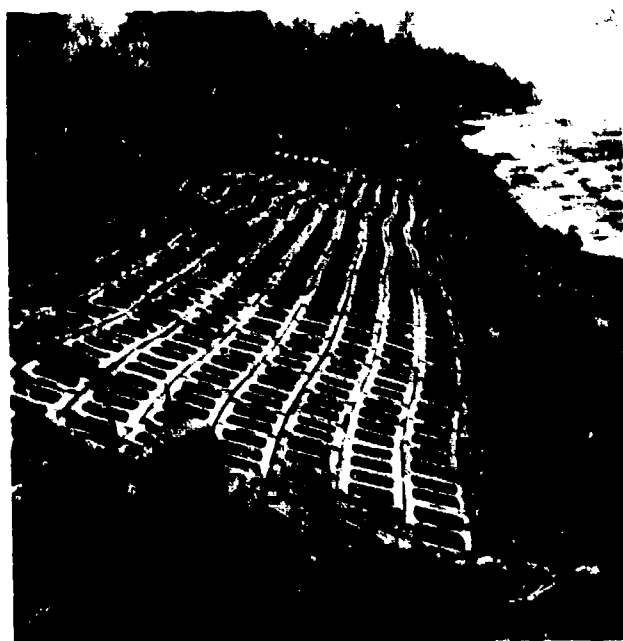
(c) Device 3 (Large Concrete-Block Revetment). The structural performance of this revetment was quite similar to that of device 2, with the overall revetment remaining intact and relatively undamaged (Figs. 2-409 and 2-410). The flexible nature and low weight of the tires make them difficult to permanently fasten together.

Figure 2-409. Large concrete-block
revetment, device 3,
Port Wing, Wisconsin,
7 May 1979.

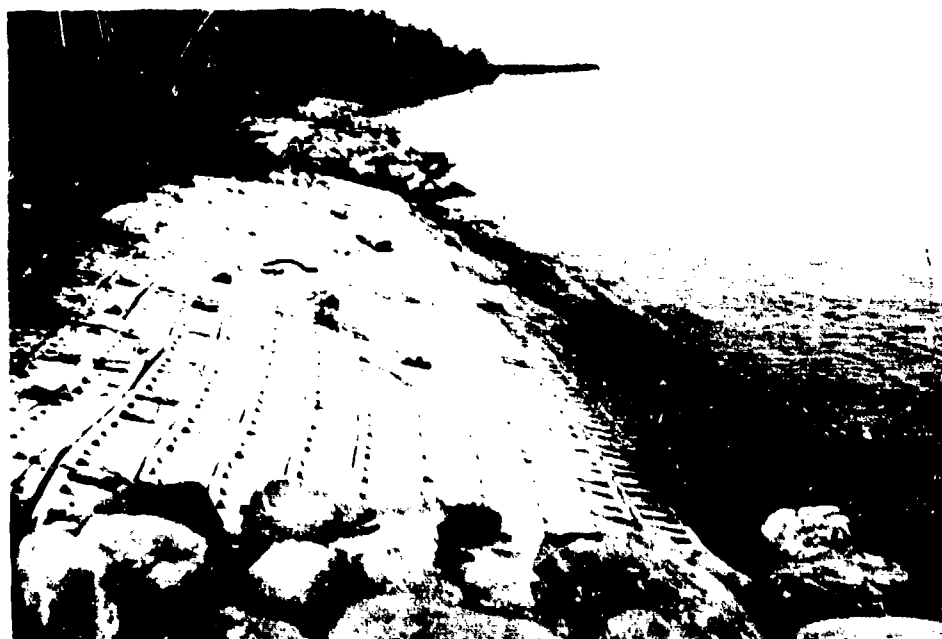
Figure 2-410. Large concrete-block revetment, device 3, Port
Wing, Wisconsin, 7 May 1979.

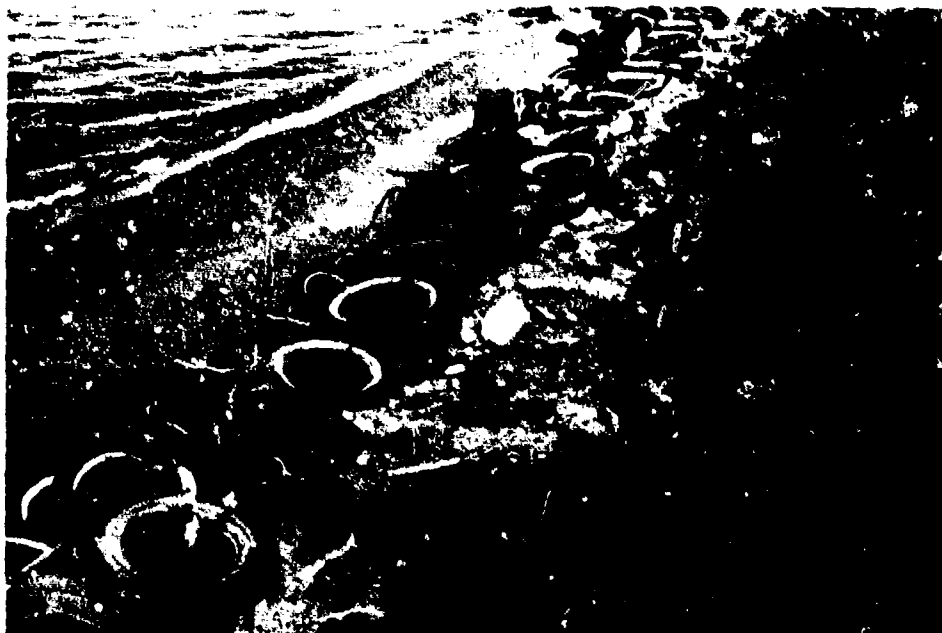
(d) Device 4 (Used-Tire Bulkhead). Although the tires did not deteriorate, the general configuration of the bulkhead underwent considerable change. Within 1 month after completion, many of the tires had separated from the structure and most of the granular fill had been washed out (Fig. 2-411). It became apparent that the tire-interconnecting devices were inadequate for holding the structure together. By the September 1979 inspection, so many tires had broken loose that a major storm could have caused severe structural damage. By May 1980, although the beach had accreted significantly, erosion occurred behind the tires (Fig. 2-412). Profiles through the used-tire bulkhead are shown in Figure 3-18 (see Sec. III), compared with those through similar devices. Comparison of the profiles of June 1979 and October 1979 shows a small amount of accretion in front of the tire stack and minor erosion behind it. No 1980 survey data were submitted, but the photos adequately depict the performance of the structure.

Figure 2-412. Device 4 as of 13 May 1980, Port Wing, Wisconsin.

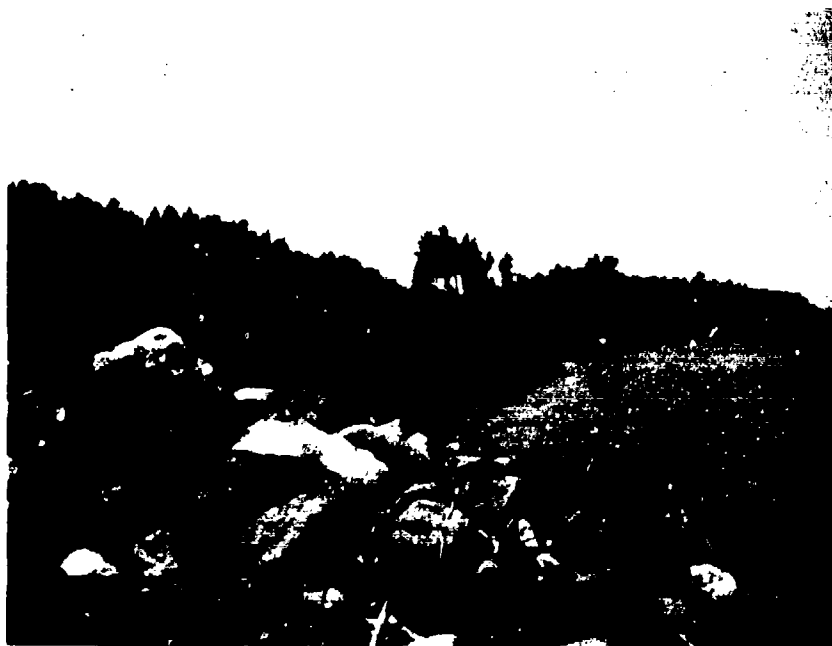
Figure 2-413. Steel and timber bulkhead, device 5, Port Wing, Wisconsin, 16 August 1979.

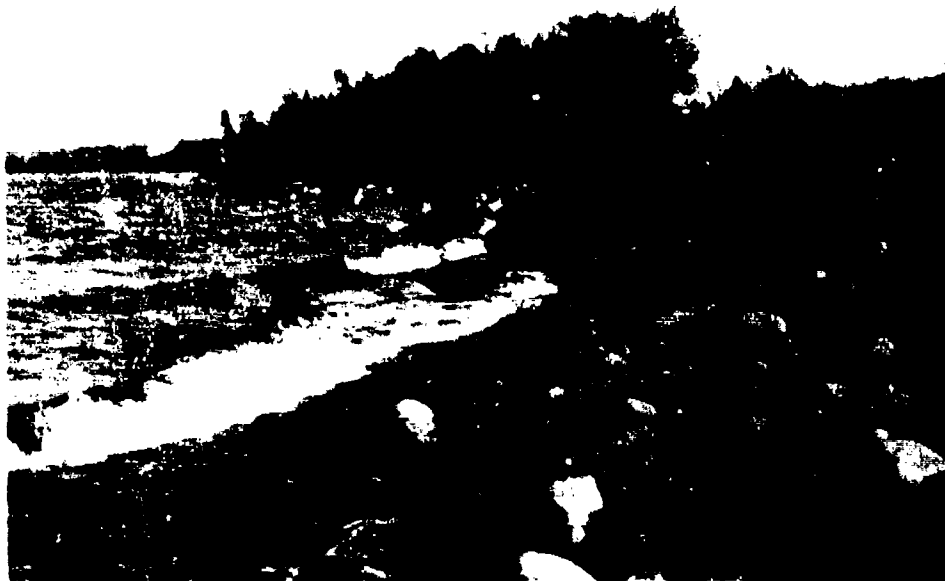
(f) Upper Bank. Good grass cover was achieved by fall 1979 (Fig. 2-415), which stabilized the upper soil surface. However, grass plantings will do little to halt erosion due to overtopping waves because of the shallow nature of the roots.

Figure 2-415. Grass planting behind structural devices, Port Wing, Wisconsin, 15 October 1979.

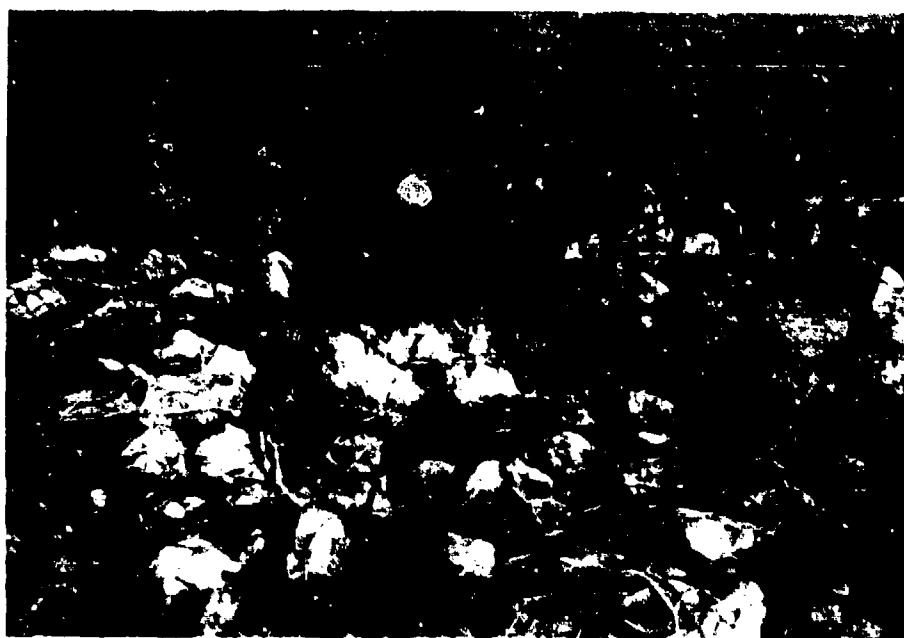
During the spring and summer of 1979 the lakeside of the gabion breakwater dropped deeper as a result of deterioration of the top layer of gabions, and the eastern end, lacking a filter-cloth base, settled a few inches. Some of the baskets were cut open at joints, and the wire mesh of others was elongated on the lakeside as the toe was undercut and rotated downward. Three baskets on the lakeside were cut open and lost most of their rockfill (Fig. 2-432). The western end of the Sta-pod breakwater settled from 6 inches to 1 foot, but no units were damaged.

Figure 2-432. Gabion basket cut, 90-percent loss of rockfill, Geneva State Park, Ohio, 6 September 1979.

(b) select the PVC-coated wire option to prevent corrosion;

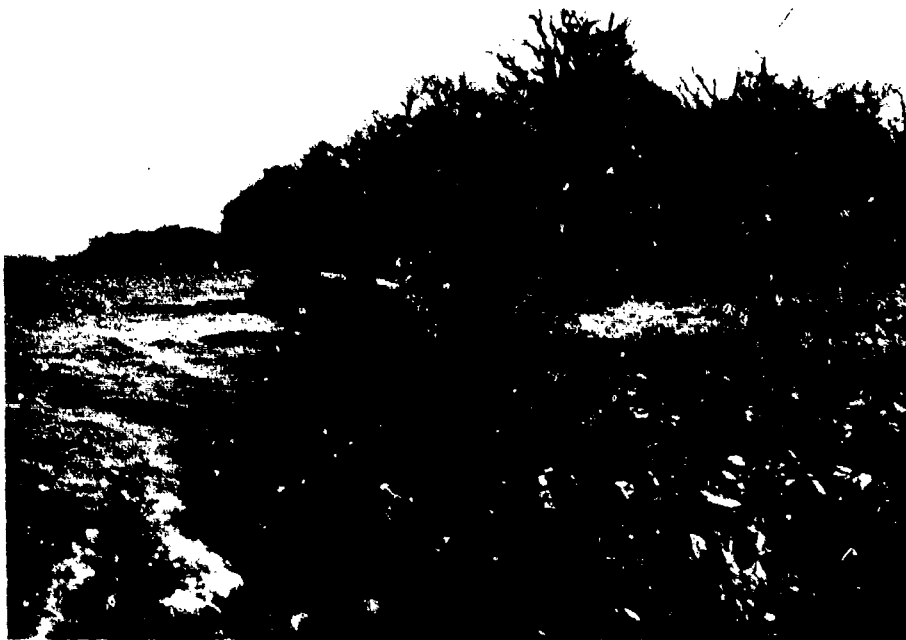
The lakeside baskets of the gabion breakwater deteriorated rapidly during the fall of 1979 as a result of toe scour, wire stretching, and corrosion. The galvanized baskets in the eastern two-thirds of the structure failed first; then the PVC-coated baskets. Before the ice cover in December 1979, all but the exposed westerly end gabions on the lakeside were broken open and the rockfill washed out (Fig. 2-433). The landward side of the structure remained intact except at the eastern end where the lack of filter cloth hastened settlement, resulting in wave destruction of both landside and lakeside gabions (Fig. 2-434).

Figure 2-433. Deterioration of the lakeside gabions,
Geneva State Park, Ohio, 11 December 1979.

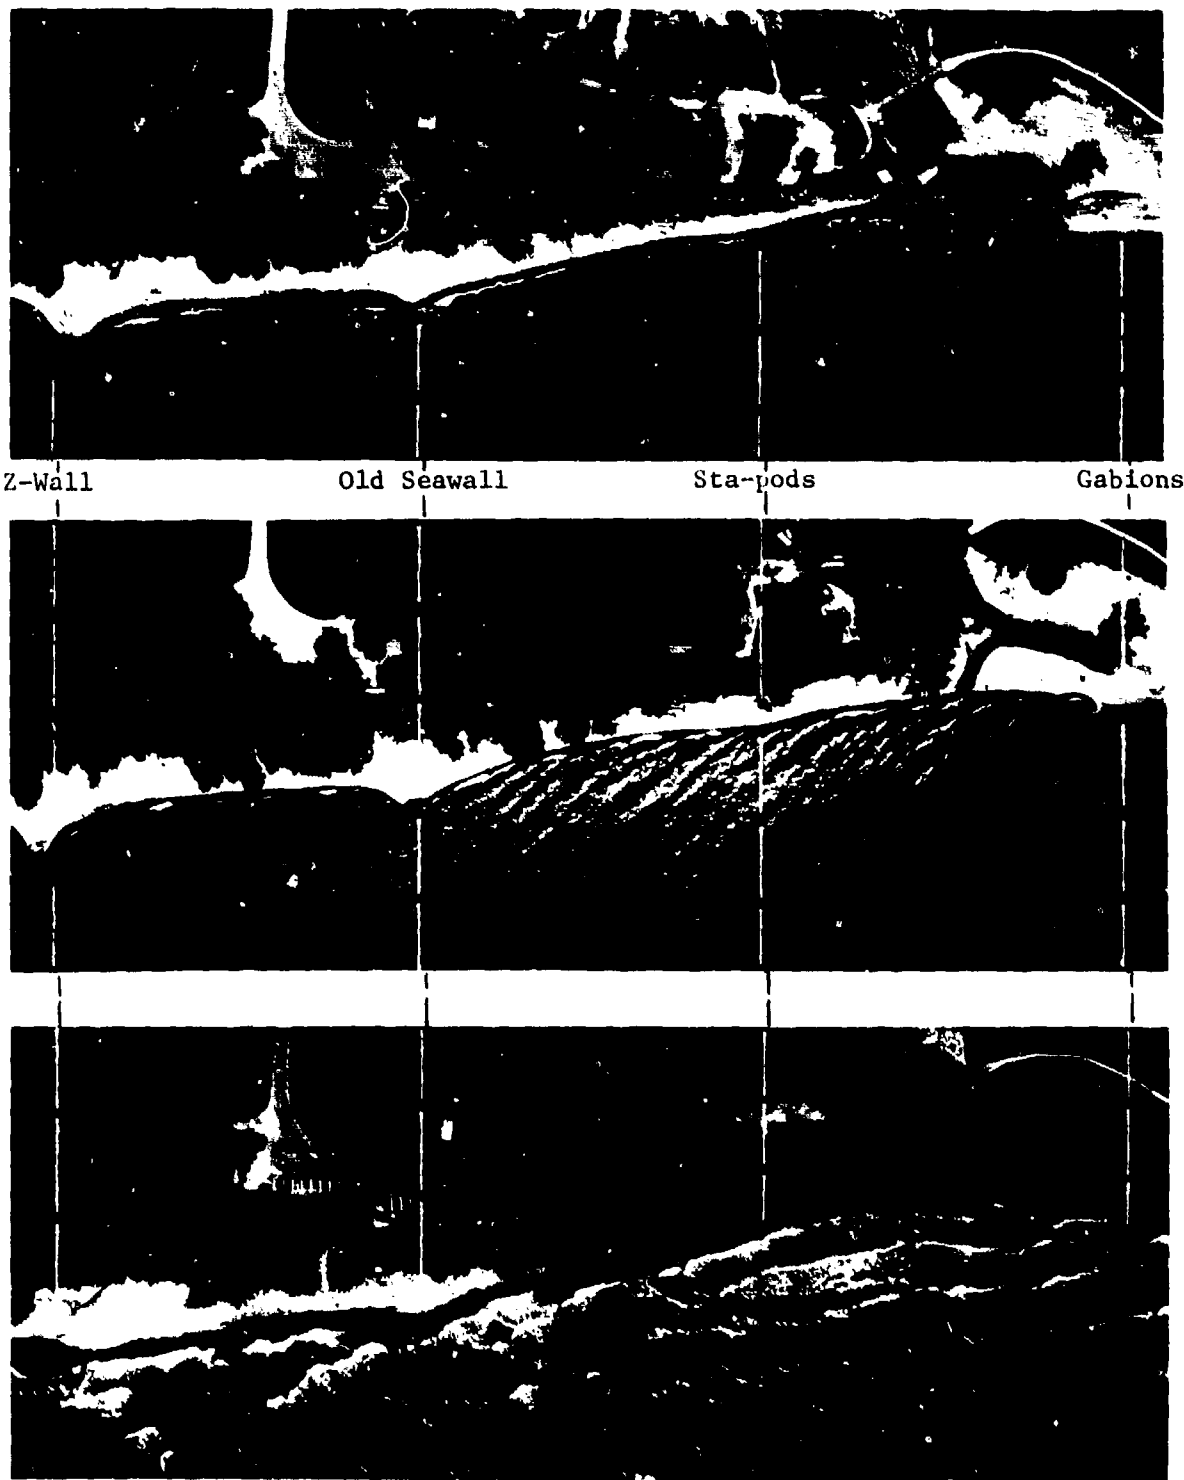
The performance of the demonstration breakwaters is best shown by the aerial photos in Fig. 2-435, one taken after the 1979 spring thaw, one near the end of summer 1979, and one after the 1980 spring thaw. During the first year, the gabion breakwater effectively controlled erosion at the mouth of Cowles Creek and built the beach out to about 50 feet, leaving a narrow waterway as the spit of sand and gravel accumulated across the creek delta, moving the outlet about 150 feet eastward. For a short time in late summer 1979, this east outlet closed and the creek flowed through the old channel westward scouring a channel behind the breakwater and around its west end into the lake. This west outlet became closed in November 1979 and soon filled with littoral material as the creek reopened its east outlet. However, as the east end of the structure deteriorated, its functional effectiveness decreased. By April 1980, most of the delta material had disappeared.

Figure 2-435. Functional performance of the demonstration breakwaters, Geneva State Park, Ohio, (top photo, 15 May 1979; middle photo, 30 August 1979; bottom photo, 23 April 1980).

Not so apparent in the 1979 summer photo is the 20-foot increase of the beach behind the Sta-pod breakwater. Notwithstanding the large void-ratio of this structure, it did absorb some of the wave energy and may have been partially effective in protecting the shoreline. However, the 1980 photo shows waves again lapping at the toe of the bluff. The existing block breakwater remained effective in spite of its deteriorated condition. The Z-wall breakwater was constructed early enough in 1978 to trap considerable material in its lee before the winter freeze. The partial tombolo it created remained relatively stable through the spring of 1980 in spite of the loss of three panels. Early profiles through the Z-wall and Sta-pod breakwaters are shown in Figure 3-78 (see Sec. III). The 1980 survey data were received too late for inclusion in the profile comparison, but the aerial photos adequately depict the performance of all three structural devices.

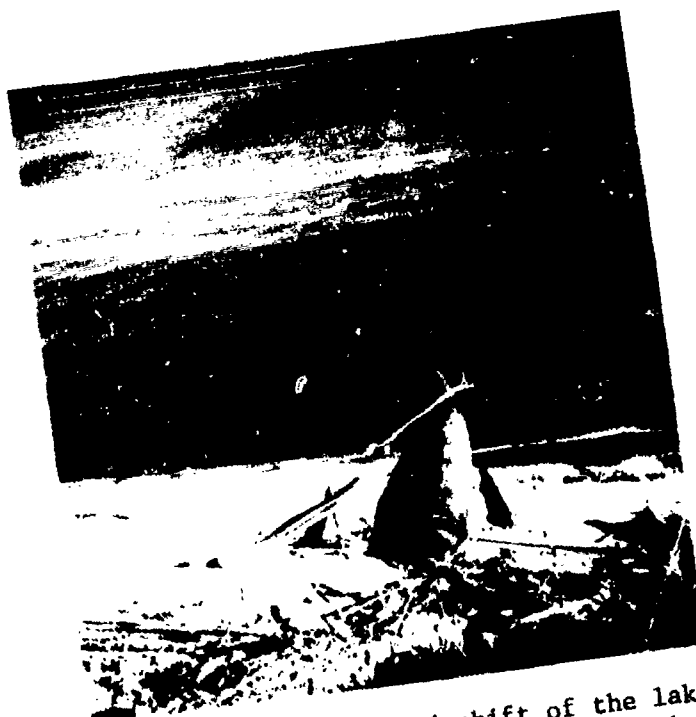
(e) Device 5 (Groin). This groin remained intact through December 1979; however, a slight westward movement occurred at the lakeward end (Figs. 2-458 and 2-459). This groin, like groin 4, was completely deflated when inspected in May 1980 and ceased to control littoral transport (Fig. 2-460). The groin may also have been damaged by ice.

Figure 2-458. Westward shift of the lake-ward end of groin 5, Ashland, Wisconsin, 31 October 1978.

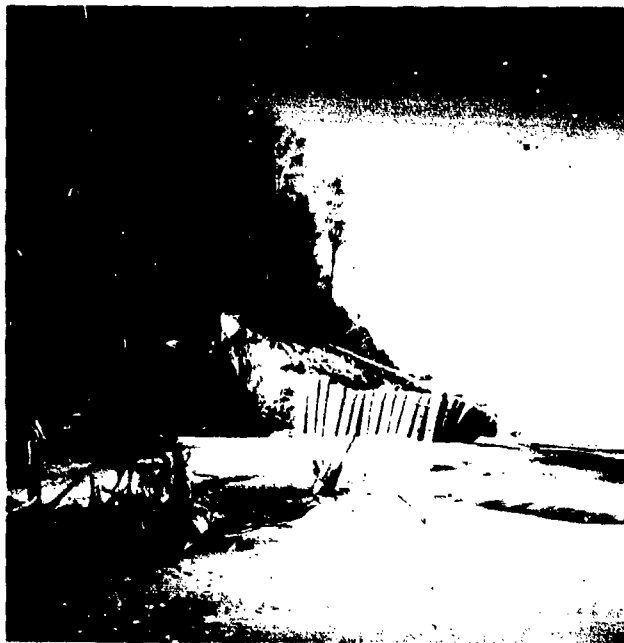
Figure 2-466. Damaged timber-pile abutment of west seawall, Ashland, Wisconsin, 31 October 1978.

Figure 2-467. Damaged timber-pile abutment of west seawall, Ashland, Wisconsin, 31 October 1978.

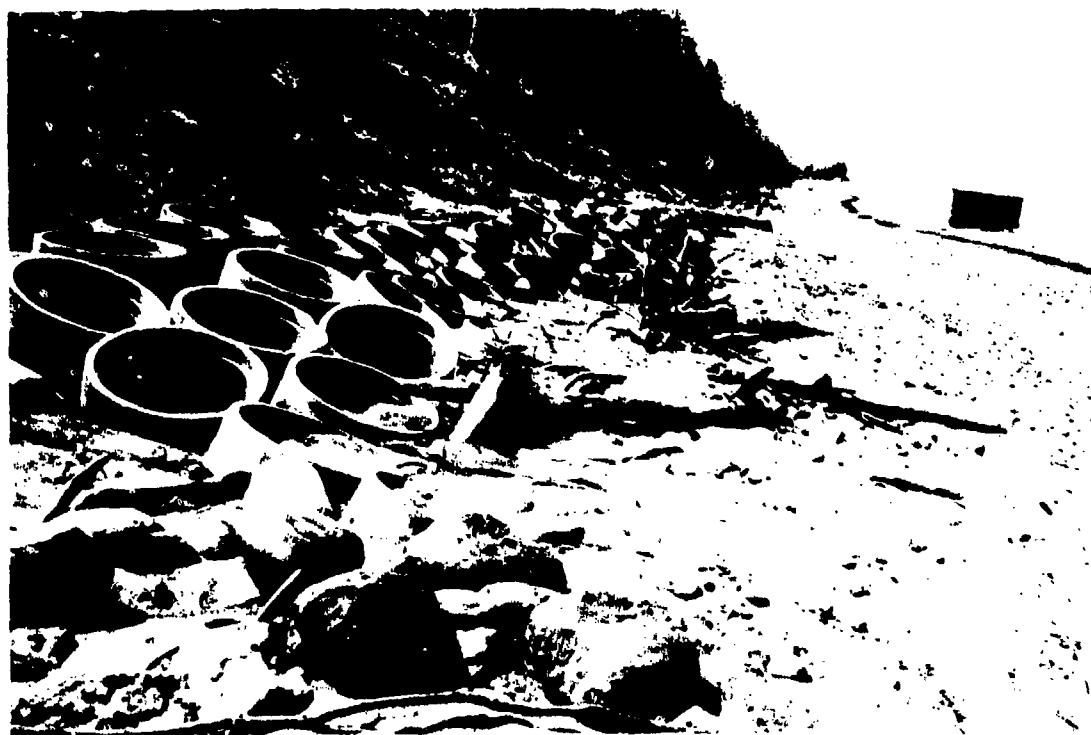
(b) Performance. During the first year, most of the rings remained stable. The eastern segment of the revetment was forced upward along its landward edge, apparently as a result of subgrade upheaval due to surcharge loading imposed by the slumping bluff. However, the western end remained in its original position. Some of the lower rows were covered with beach sand, and rings farther up the slope continued to fill with sand (Fig. 2-489).

Figure 2-489. Nami rings after 7 months of service, note displacement and sandfill, Little Girls Point, Michigan, 21 May 1975 (from Brater, Armstrong, and McGill, 1975).

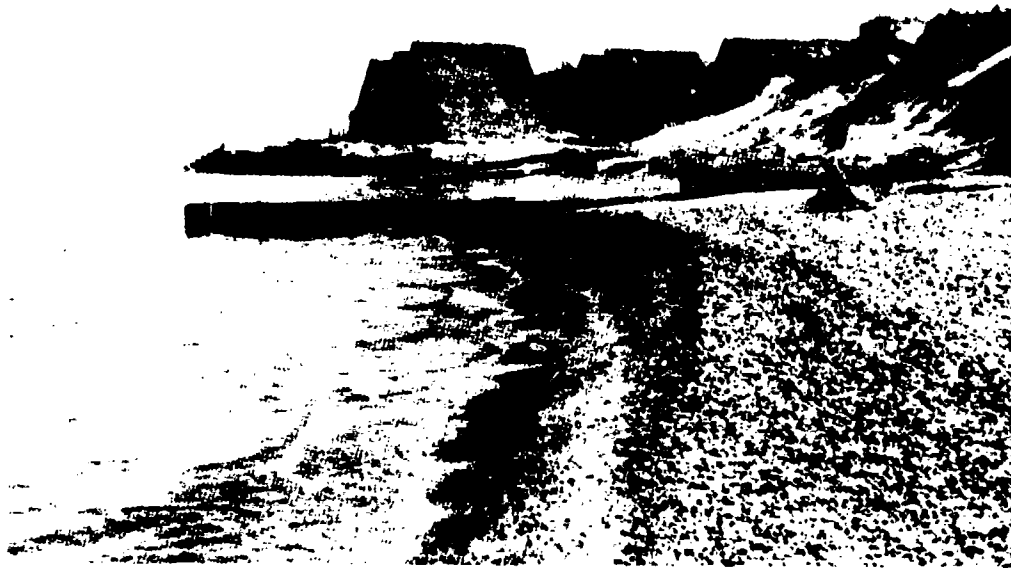
The timber groin performed well and showed no sign of deterioration (Fig. 2-494), thus providing additional evidence that wood is an excellent material for groin construction in the Great Lakes. An impervious timber-pile groin is an old and proven means of shore protection in areas where there is adequate littoral drift moving predominantly in one direction. The relatively wide spacing between the groins did not reduce their functional effectiveness, and the system has protected the site by trapping sand and raising the beach profile. Much of the sand retained by the Longard tube before it failed is still on the beach, and it together with that retained by the timber groin is still protecting the bluff, although some minor slumping has occurred. This slumping is probably due to factors other than simply wave attack, such as wind erosion or heavy foot traffic on the bluff.

Figure 2-494. Timber groin in good condition, Lincoln, Township, Michigan, 6 May 1976 (from Brater, Armstrong, and McGill, 1977).
